AFML-TR-78-160
Volume I

COST EFFECTIVE REPAIR TECHNIQUES FOR TURBINE AIRFOILS

GENERAL ELECTRIC COMPANY

NOVEMBER 1978

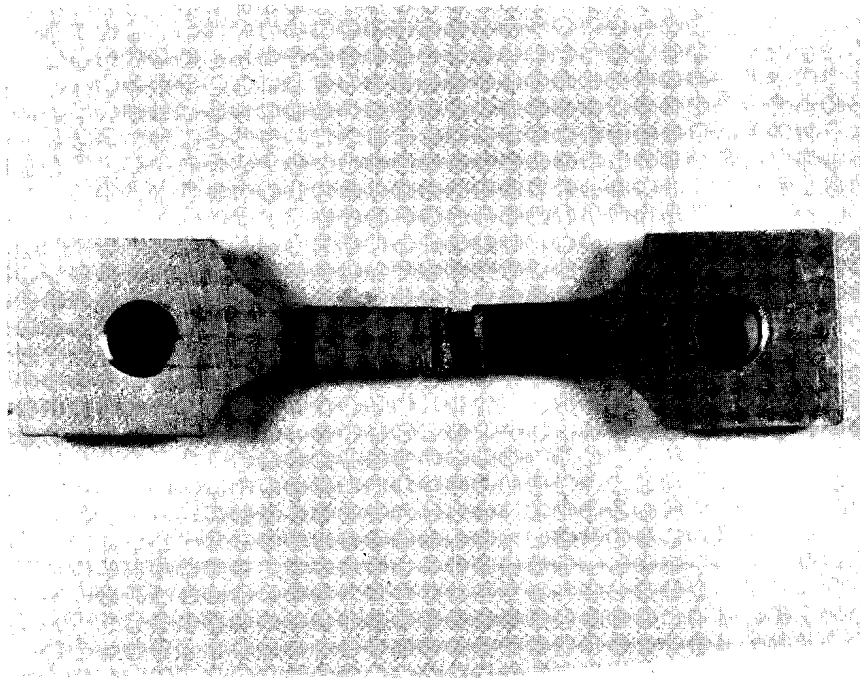
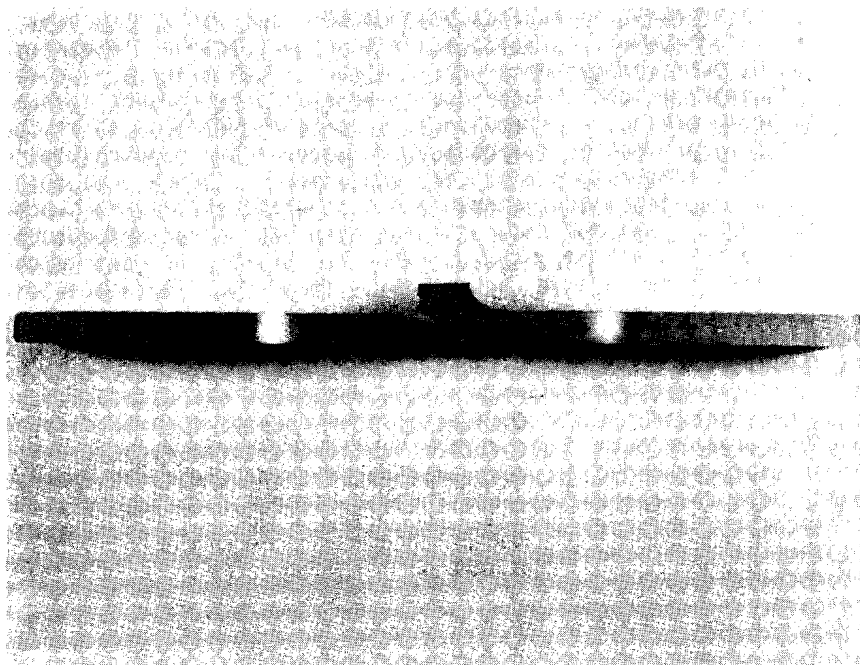
In all cases the failure occurred in the X-40 base metal at the edge of the overlap fillet radius and a typical failure is shown in Figure 6.

Figure 6. Front and Side View of Tensile Shear Specimen
Showing Typical Failure Location

The average results of three tests pulled at 2000#/min. load rate were 34.5 ksi for the R80/D15 ADH alloy. In each test, failure occurred in the R80 base metal at the edge of the bond line. Figure 6 illustrates a typical failure.

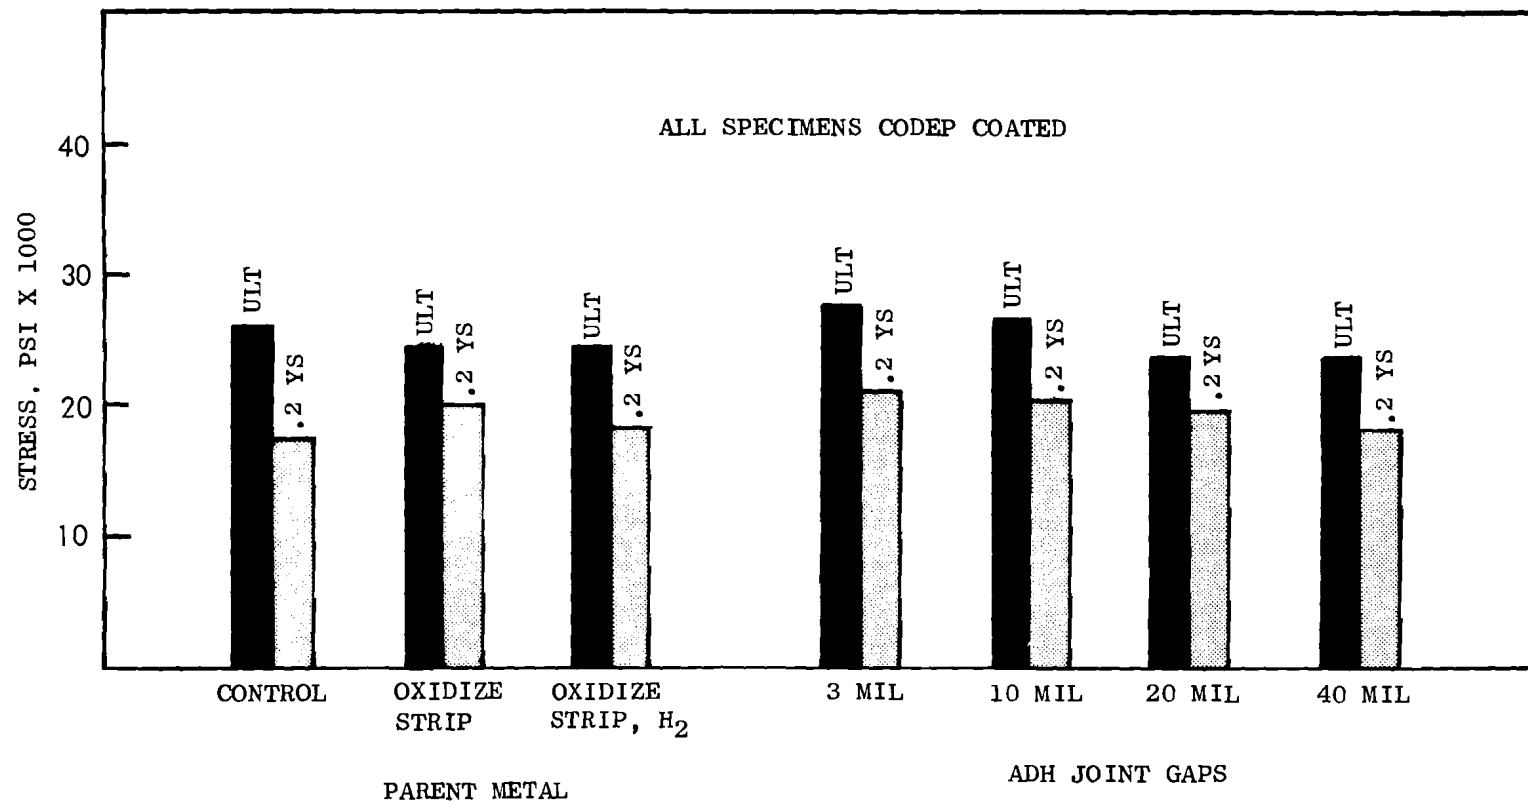
The 1800°F tensile results are shown in Figure 7. Equivalent ultimate and 0.2% yield strength values are shown for all parent metal and ADH joints tested.

Figure 7. Tensile Properties of X-40 Parent Metal and Activated Diffusion Healed (ADH) Joints at 1800°F

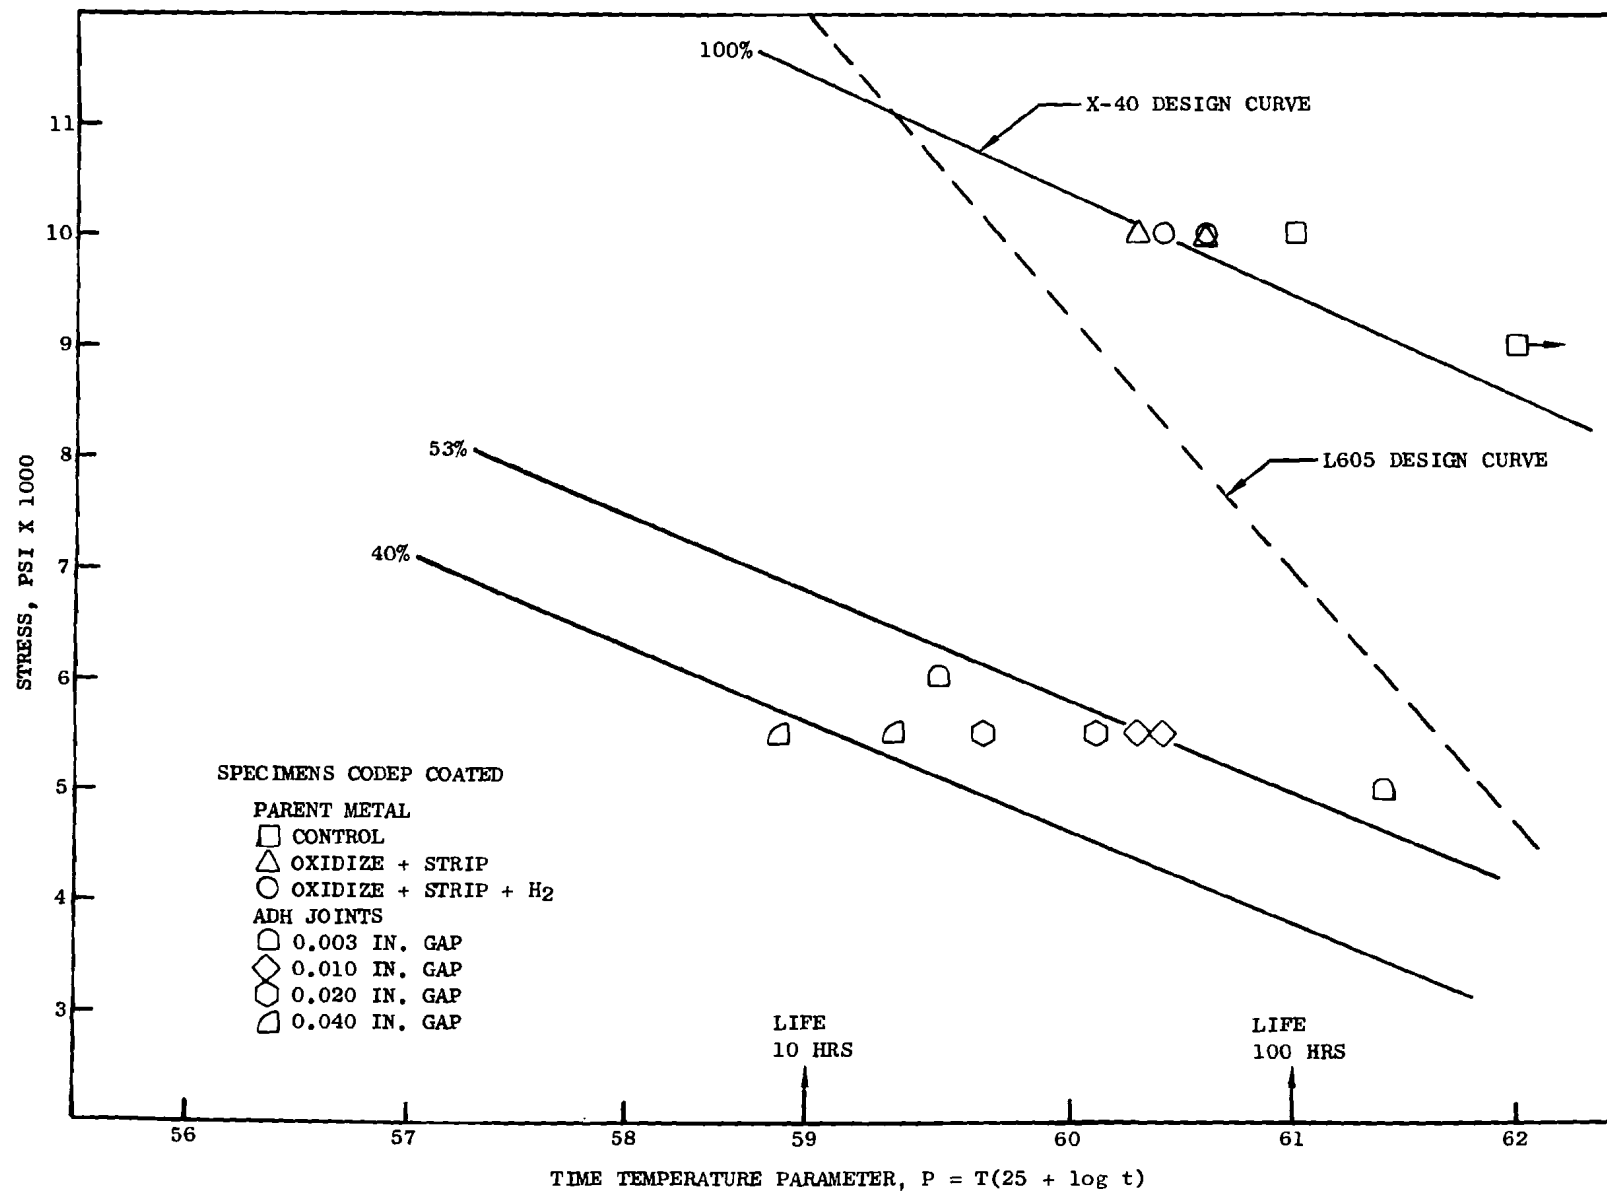
The 1800°F stress rupture results plotted in Figure 8 show a reduction in life for the ADH repair. The commercial weld repair which uses L-605 alloy filler is also plotted on the graph. It has improved load carrying ability over the ADH alloy up to 1000 hours life. However, at longer times the ADH repair will be superior.

Figure 8. Stress Rupture Properties of X-40 Parent Metal and Activated Diffusion Healed (ADH) Joints at 1800°F

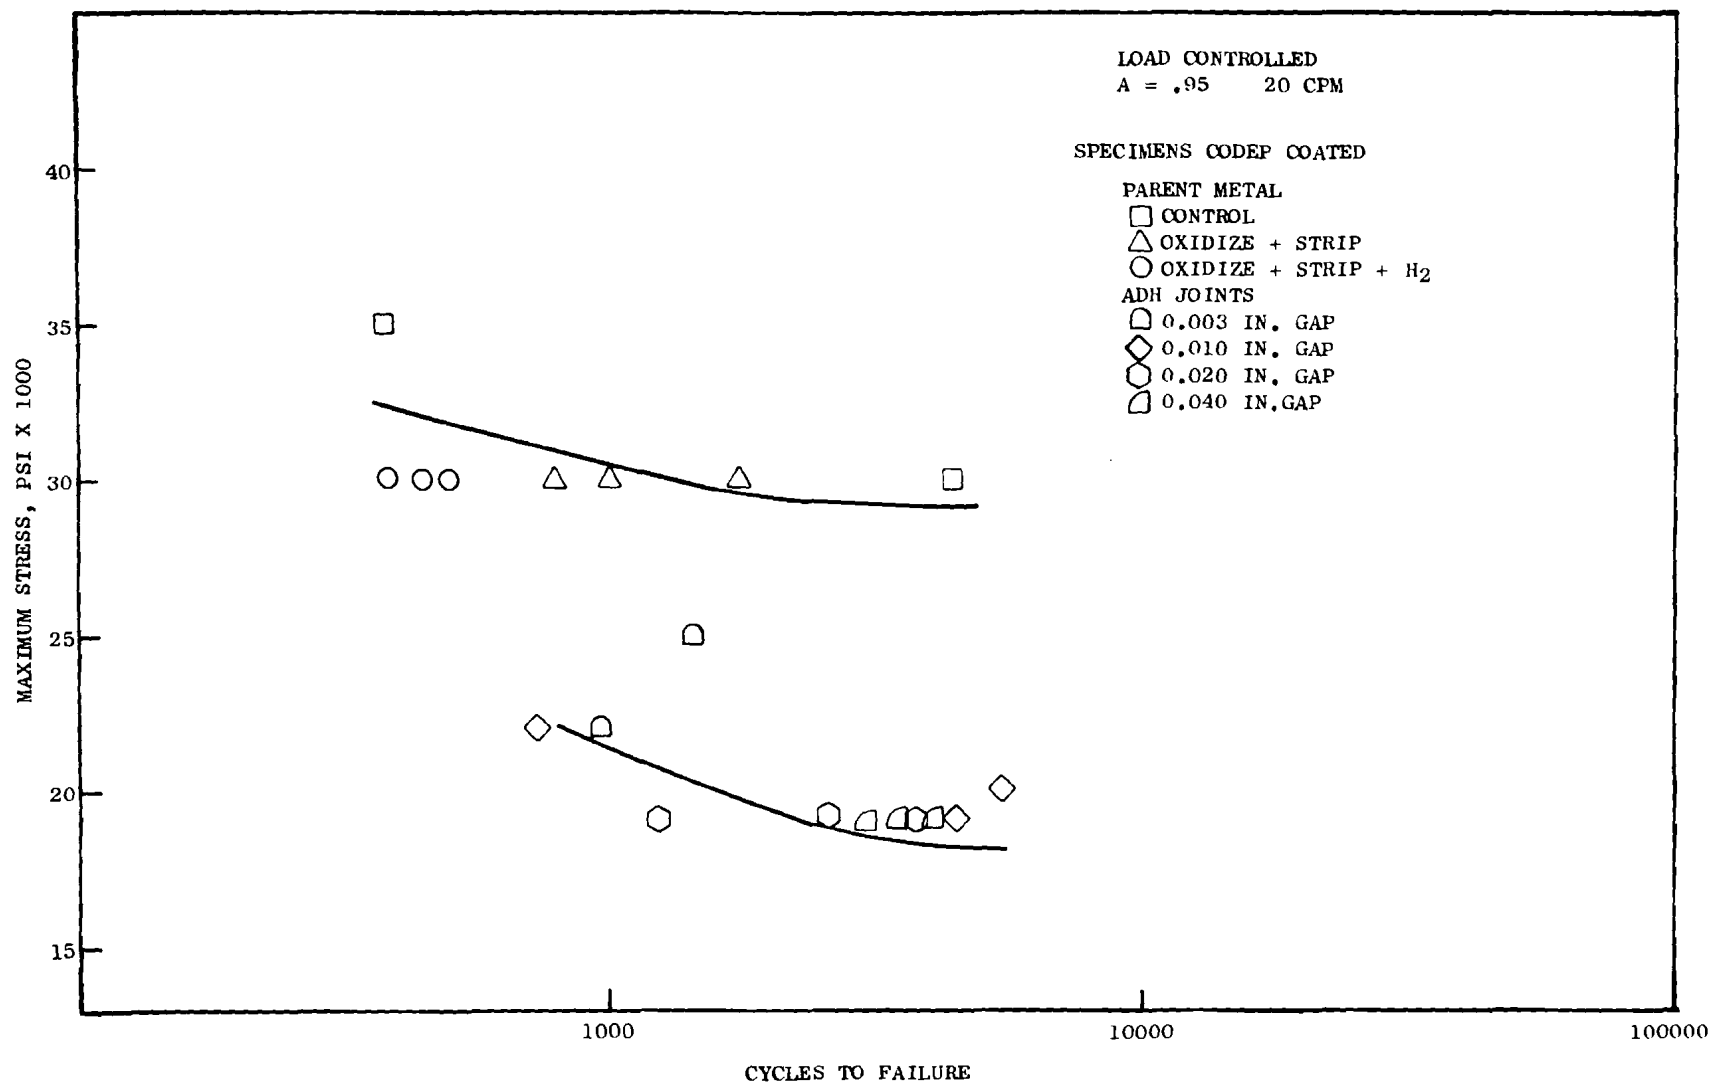
The results are shown in Figure 9. The effect of gap width is not significant. However, a joint reduces the cyclic load carrying ability by 40%. The hydrogen cleaning also is shown to cause a reduction in life for the limited tests conducted. This effect was not evident in either stress rupture or tensile testing.

Figure 9. Low Cycle Fatigue Properties of X-40 Parent Metal and Activated Diffusion Healed (ADH) Joints at 1800° F

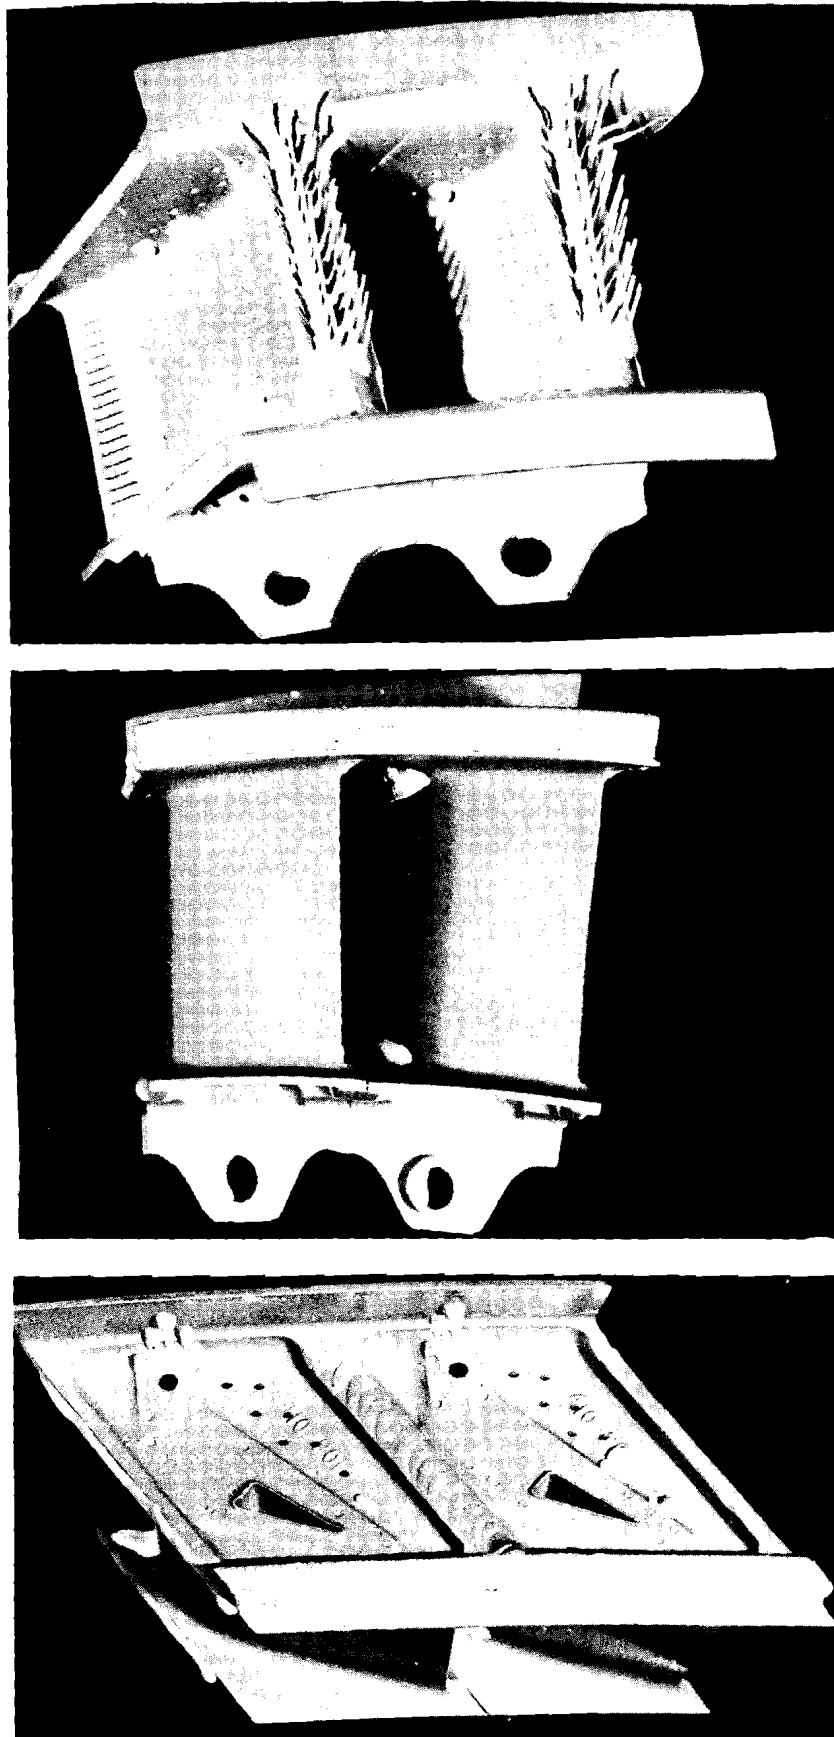
Because of the extensive cracking and severe leading edge distress, typified in Figure 4 & 10, it was found to be more cost effective to use a zone alloying concept with maintenance of cooling hole dimensions by installing quartz rod pins. This method is shown in Figures 11 and 12.

Figure 11. Example of ADH Repair Alloy Application on TF39 Stage 1 HPT Vane

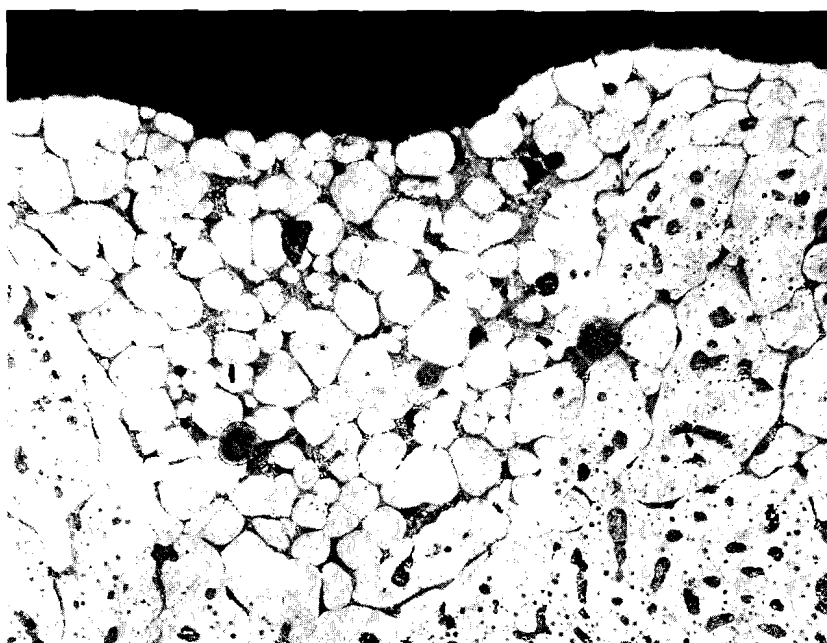
H-33 JOINT IN X-40 MATERIAL

D-15 JOINT IN X-40 MATERIAL

Figure 13. Photomicrograph of ADB Repaired Cracks in X-40 Material

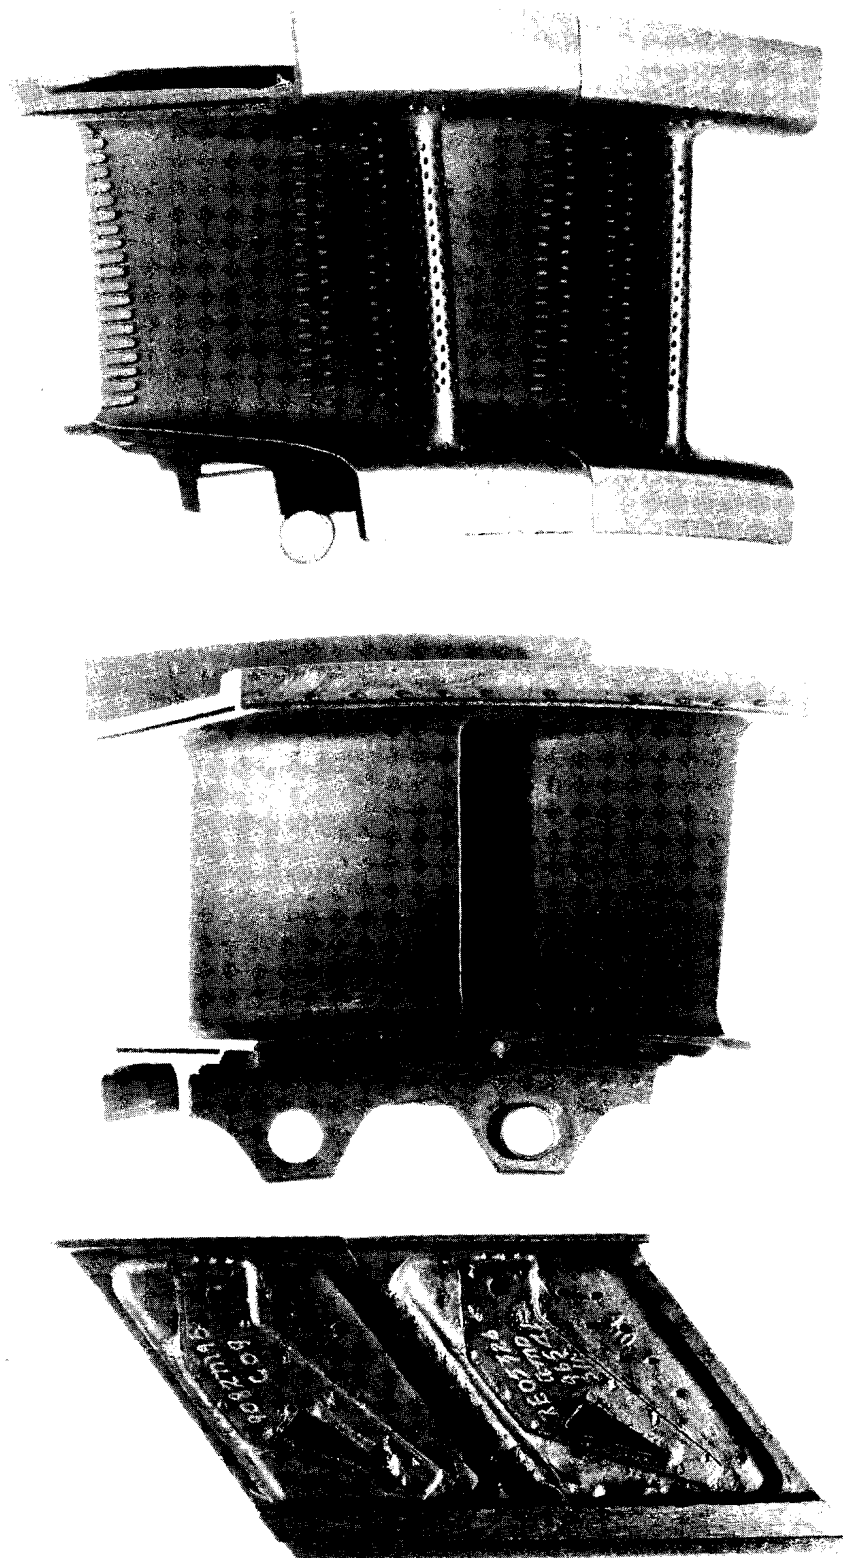
TOP VIEW - VANE LEADING EDGE
 MIDDLE VIEW - VANE TRAILING EDGE
 BOTTOM VIEW - VANE OUTER PLATFORM

Figure 14. Finished TF39 Stage 1 HPT Vane Repaired by the ADH Process

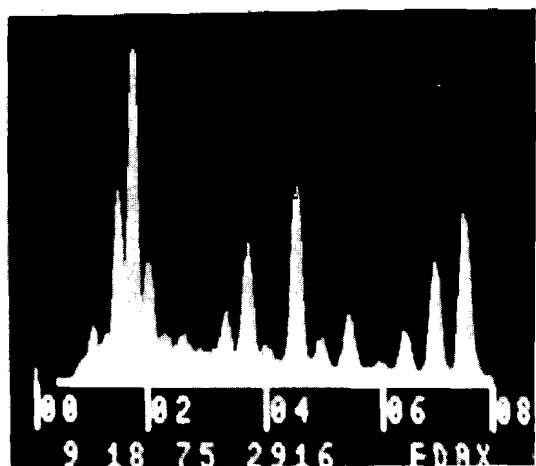
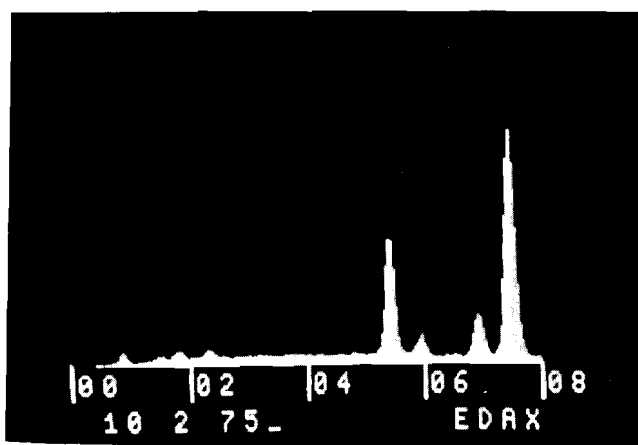
During the scale-up effort scrap vanes with existing engine induced cracks were used to verify the cleaning effectiveness of F⁻ cleaning. After each run, cracks were broken open and cleanliness verified by visual and SEM analysis (Figure 25). Although this was desirable for the initial efforts this type of analysis was impractical for service shops.

RENE' 80 CRACK SURFACE APPEARANCE. LEFT: AS ENGINE RUN,
RIGHT: FLUORIDE ION CLEANED

Figure 25. SEM Analysis of Rene' 80 Crack Surface Before and After
Fluoride Ion Clean

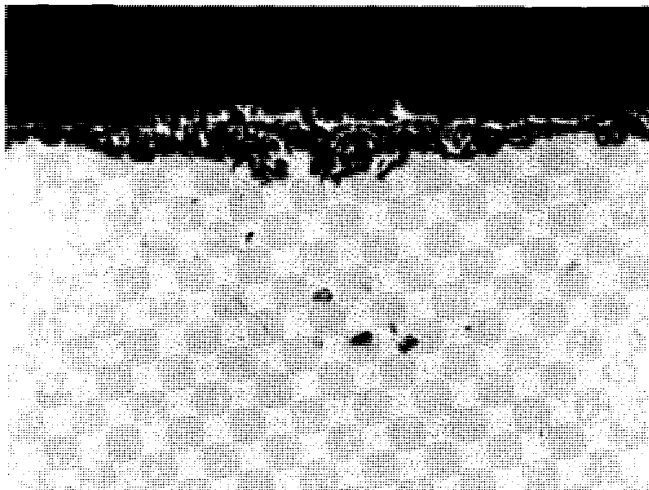
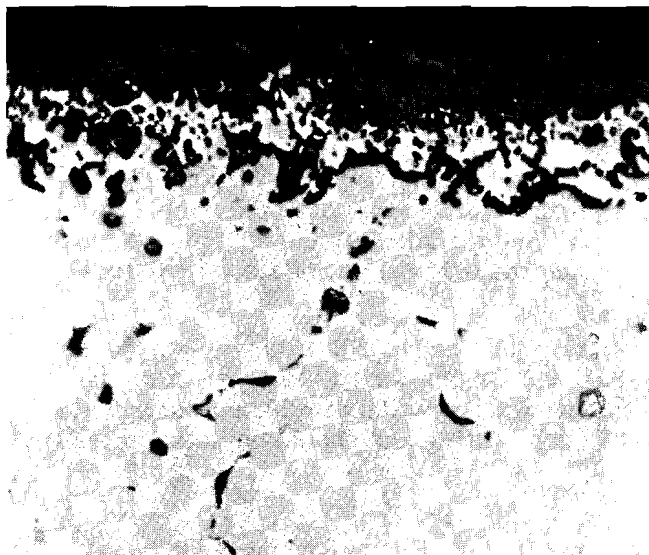
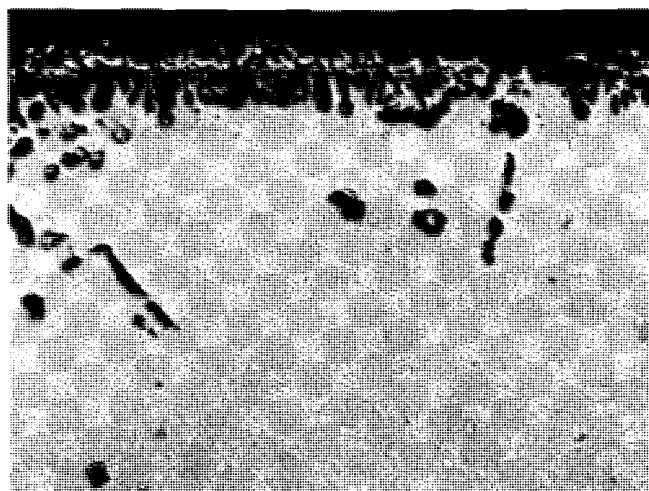
A controlled process evaluation was initiated to study this phenomena. Kirkendall voids were not observed immediately after the F⁻ cleaning portion of the process; however, after both subsequent vacuum clean and/or Codep coating, they were observed. This indicated that a diffusion mechanism became operative during the subsequent thermal exposure and affected a rapid diffusion of substrate elements to the alloy depleted surface leaving the observed Kirkendall voids. The oxidation characteristics of the resulting surfaces are shown in Figure 29 along with the normal oxidation of R80 on a stripped and oxidized component. The depleted alloy layer left by F⁻ cleaning and subsequent oxidation testing resulted in catastrophic oxidation attack. Additional thermal exposure in the vacuum clean cycle allowed more diffusion and thus reduced the amount of oxidation attack.

Stage 2 Vane - CODEP stripped
and oxidized at 2050°F/23 hrs.

Stage 2 Vane - CODEP stripped,
F-cleaned w/CrF₃, and oxidized
at 2050°F/23 hrs.

Stage 2 Vane - CODEP stripped,
F-cleaned w/CrF₃, vacuum cleaned
and oxidized at 2050°F/23 hrs.

Figure 29. Oxidation Characteristics of Rene' 80

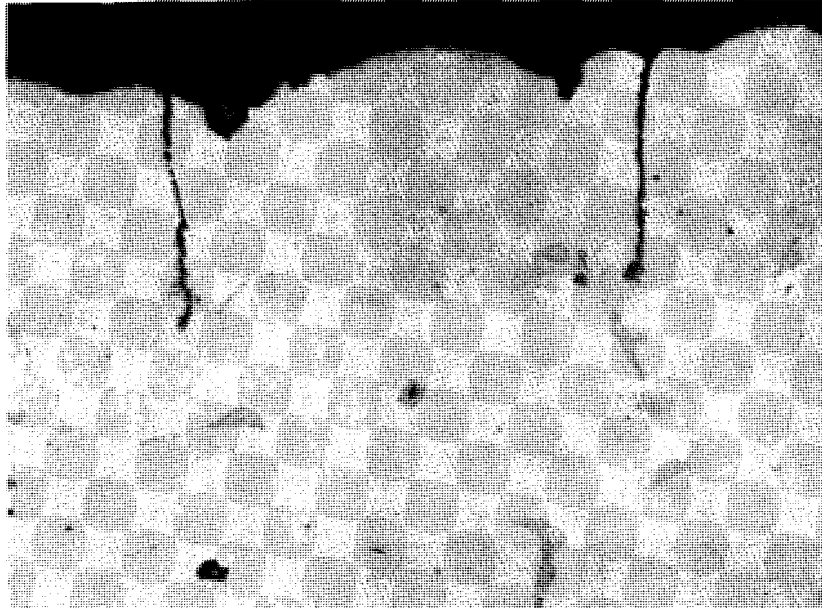
This study indicated that it was necessary to remove this alloy depleted layer after F⁻ cleaning and both chemical and mechanical means were utilized to affect this metal removal. Figure 30 shows a vane segment which had 0.001" chemically removed from the surface after F⁻ cleaning and even though the Codep coating has failed (cracked), there is no oxidation attack of the diffusion zone/substrate interface. A mechanical method of metal removal was also used and after some evaluation was included as part of the established process.

Figure 30. Fluoride Ion Cleaned Vane with .001" Chem Milled from Surface, Codep Coated, and Oxidized at 2050°F/23 Hrs 500x

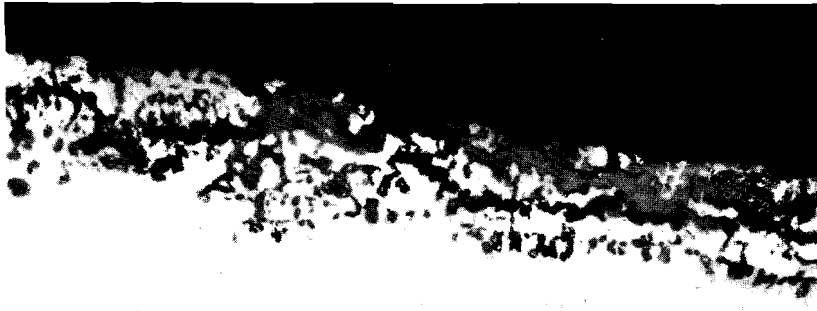
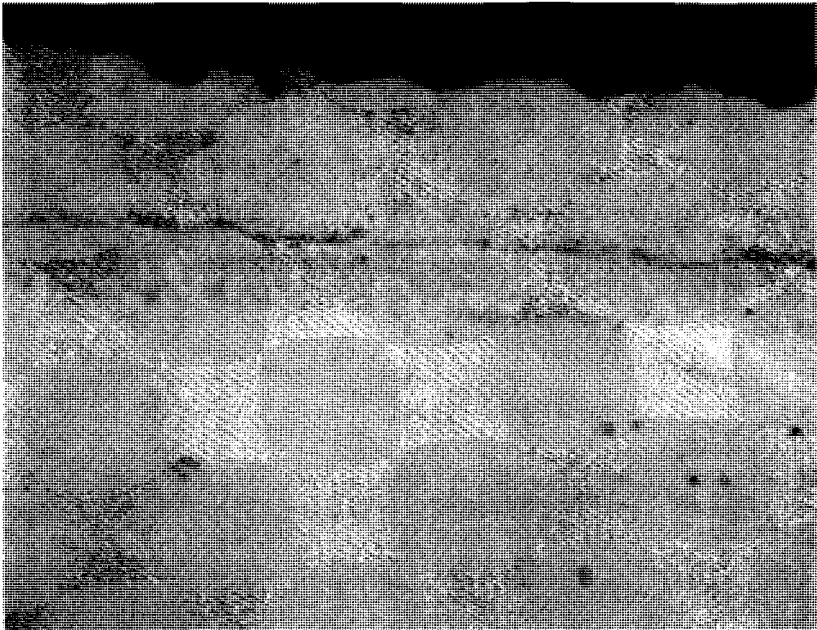
Stage 2 vane CODEP stripped,
F-cleaned w/ NH_4F + Cr, vacuum
cleaned, and oxidized at
2050°F/23 hrs.

Stage 2 vane CODEP stripped,
F-cleaned w/ NH_4F + Cr, vacuum
cleaned, CODEP coated, and
oxidized at 2050°F/23 hrs.

Figure 31. Stage 2 HPT Vane Fluoride Ion Cleaned and Oxidized 500x

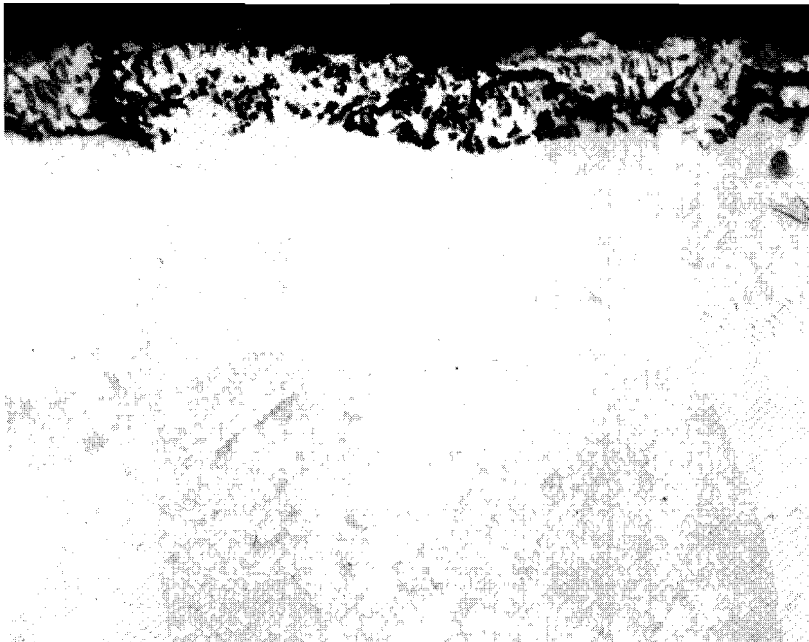
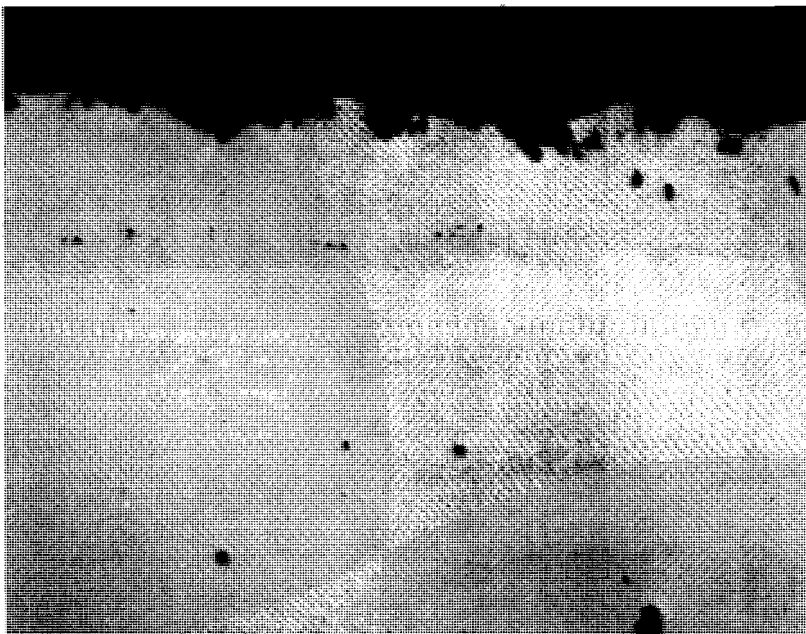
Stage 2 vane CODEP stripped,
F-cleaned w/ NH_4F + Cr, grit
blasted, vacuum cleaned, and
oxidized at $2050^\circ\text{F}/23$ hrs.

Stage 2 vane CODEP stripped,
F-cleaned w/ NH_4F + Cr, grit
blasted, vacuum cleaned,
CODEP coated, and oxidized
at $2050^\circ\text{F}/23$ hrs.

Figure 32. Stage 2 HPT Vane Fluoride Ion Cleaned, Grit Blasted,
and Oxidized

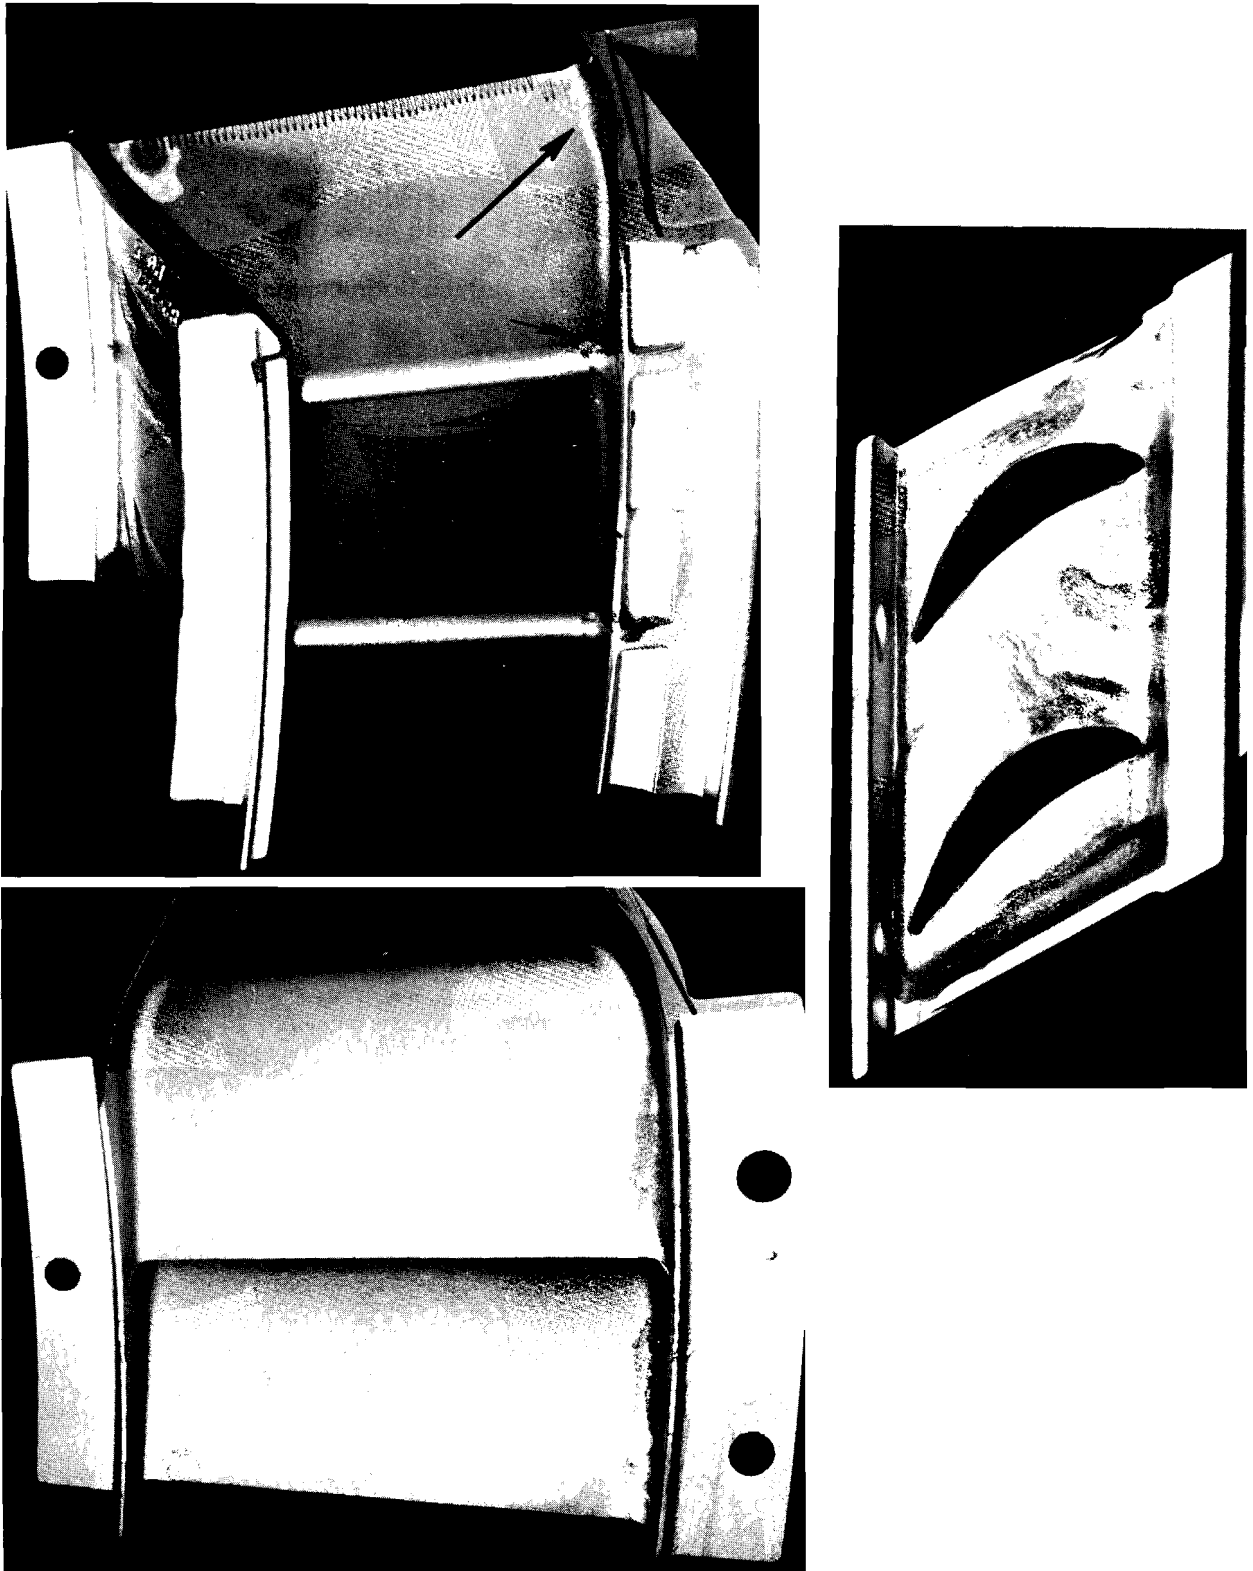
ADH processing of the 40 piece pilot lot was accomplished after the grit blast or dehusk operation and vacuum bright anneal at 2200°F/2 hours. Discrepant areas which were cracked or exhibited worn metal were alloyed with the 50/50 mixture of Rene' 80 and D-15 powder and ADH repaired as illustrated in Figure 34. Metallographic sections taken through scrap vanes processed with the pilot line parts are shown in Figure 35 after the diffusion cycle. The pilot vanes were then blended by grinding and polishing to provide smooth surface contours, finish machined on the bolt hole mounting rails, and Codep coated. Air cooling inserts were installed and the vanes were aged and submitted for final inspection. Figure 36 illustrates the ADH repaired components.

Figure 34. Typical Appearance of F-Cleaned and ADH
Repaired Rene' 80 TF39 Stage 2 HPT Vanes

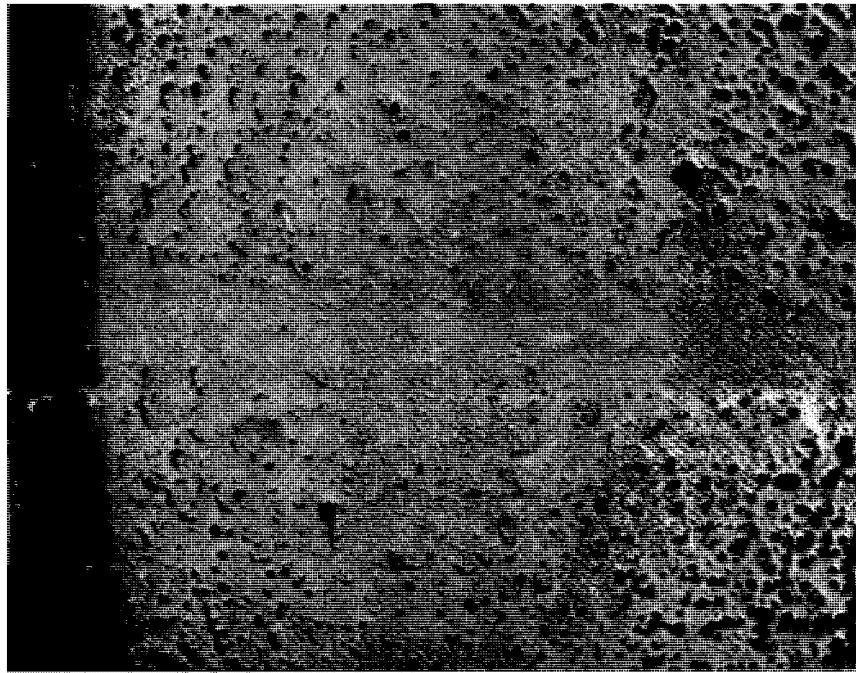
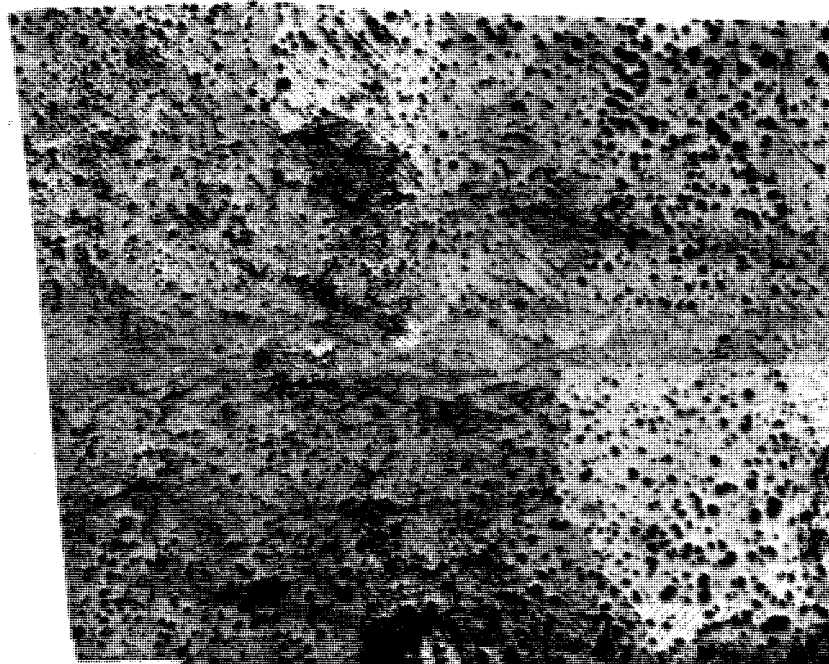
Figure 35. Photomicrograph of Rene' 80 TF39 High Pressure Vane ADH Repair After Complete Diffusion Cycle

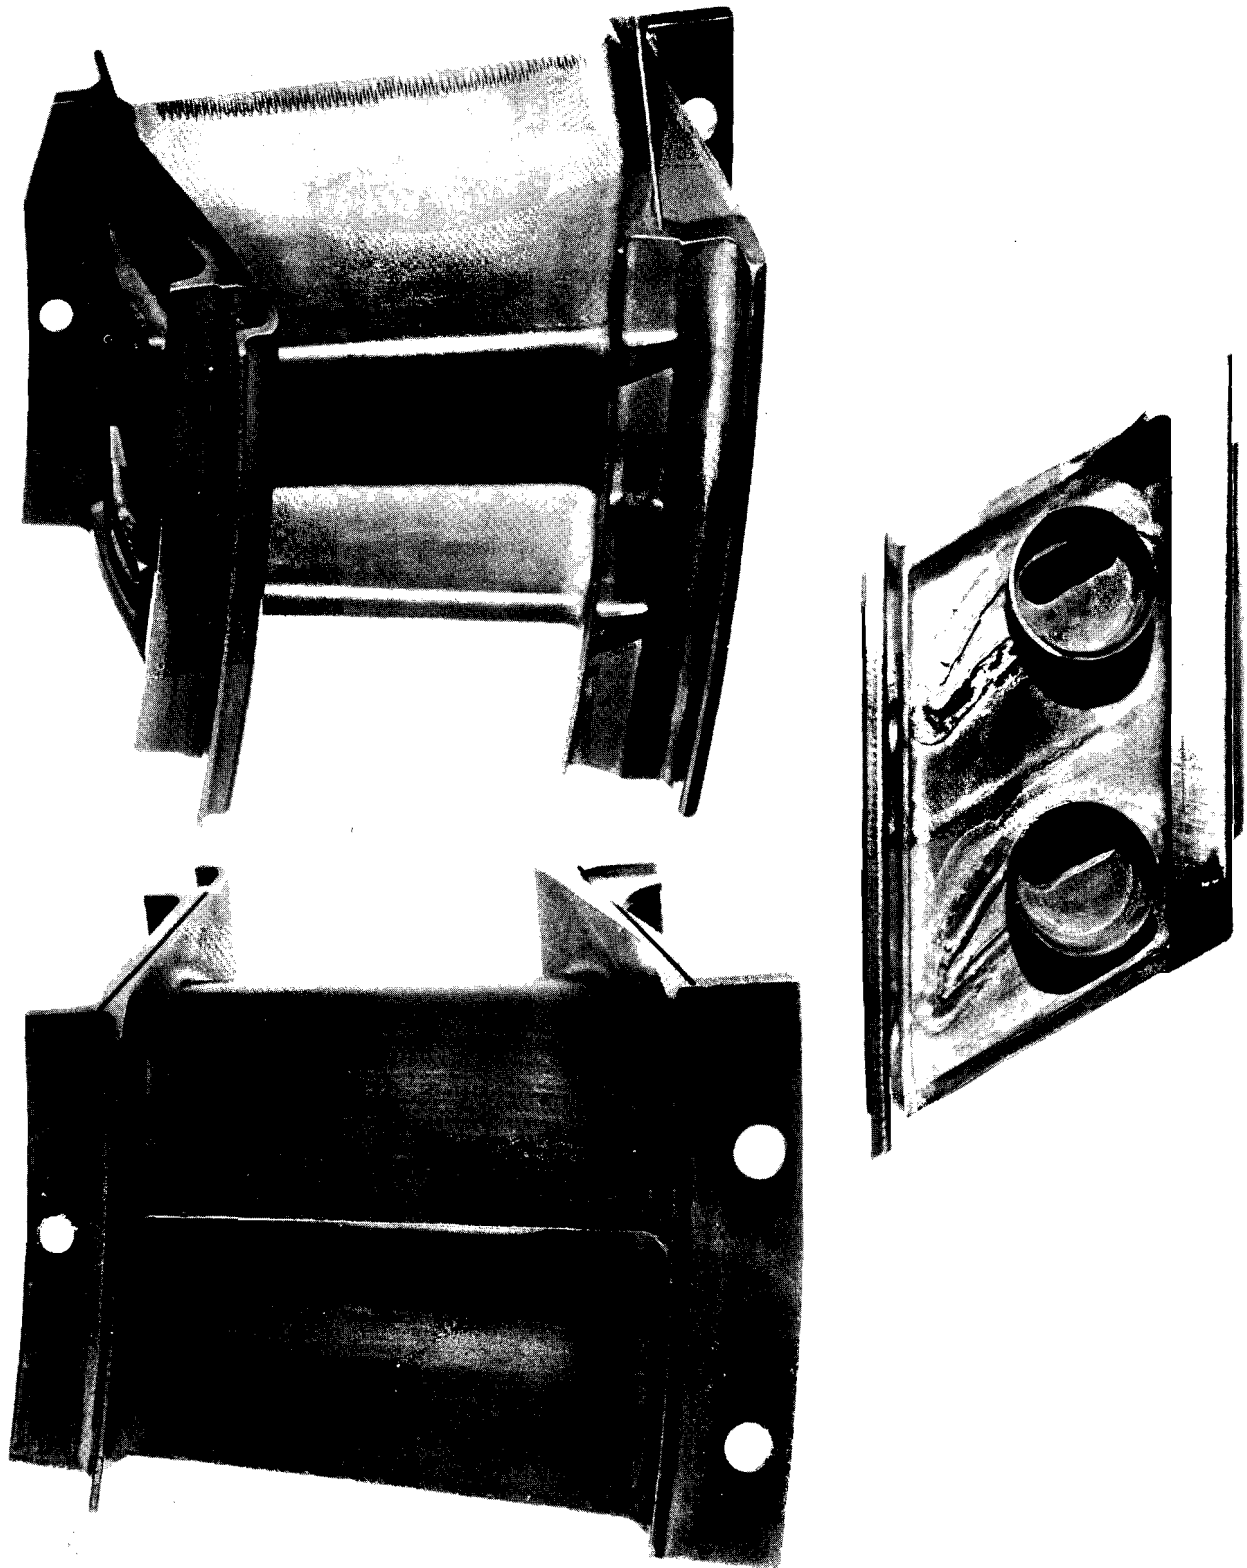
The 40 piece pilot line lot has been completely processed through final inspection with a 100% yield. The ADH repaired stage 2 vanes have been submitted for TF39 engine test and results are expected early in 1979.

Figure 36. View of Rene' 80 TF39 Stage 2 HPT Vane
After ADH Repair, Codep Coat and Brazing
of Air Cooling Insert

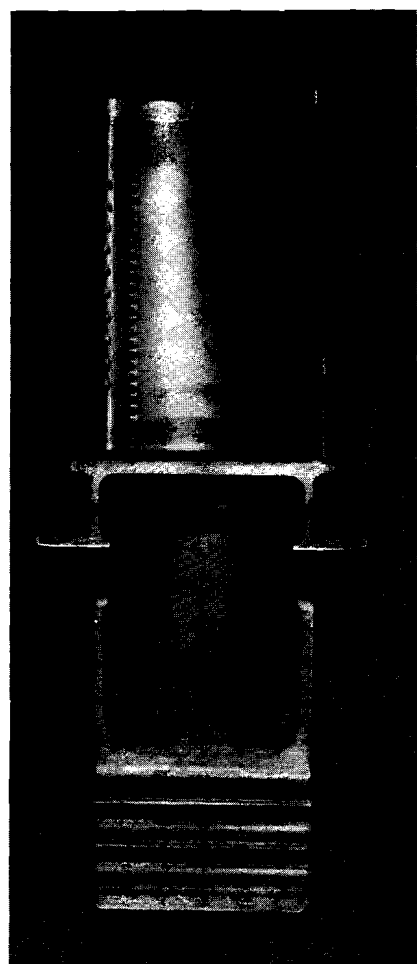
CRACKS THROUGH
TIP CAP

OCCURRENCE
FACTORY \approx 2000 CYCLES

Figure 37. HPTR Stage 1 Blade with Squealer Tip
Cracks Extending Below Tip Cap

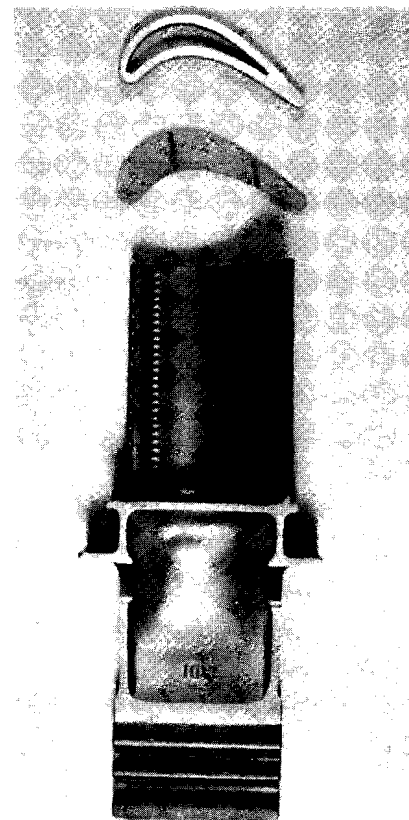
Figure 38. Mini-Bond Tip Replacement Concept on TF39/CF6-6
Stage 1 HPT Blade

The primary goal of this task was to extend the current repairable limits for Rene' 80 blade tip distress. The tip replacement process by mini-bonding was selected as the means by which much serviceable/non-repairable hardware might be salvaged. Excessive tip rub in engine operation generally results in burns and/or cracks resulting at the squealer tip and extending through the tip cap into the airfoil section itself. Figure 37 shows this condition and is illustrative of the potential of a mini-bond repair for replacement of the defective tip and cap. The concept by which the repair was developed is shown in Figure 38. This concept then served as the basis for establishment of the initial repair procedure shown below:

- a. Inspect incoming vane airflow.
- b. Strip Codep coating.
- c. Separate paired blades.
- d. Inspect blades to assess damage and repair needs.
- e. Grind tip for mini-bond repair.
- f. Grit blast clean blade tip area.
- g. Vacuum bright anneal blade to finalize cleaning at 2200°F/2 hours.
- h. Dimensional inspect tip cap height.
- i. Assemble tip cap with presintered D-15 ADB alloy to blade.
- j. Mini-bond tip cap.
- k. Dimensional inspect tip cap height for gap upset and visual inspect for complete bonding.

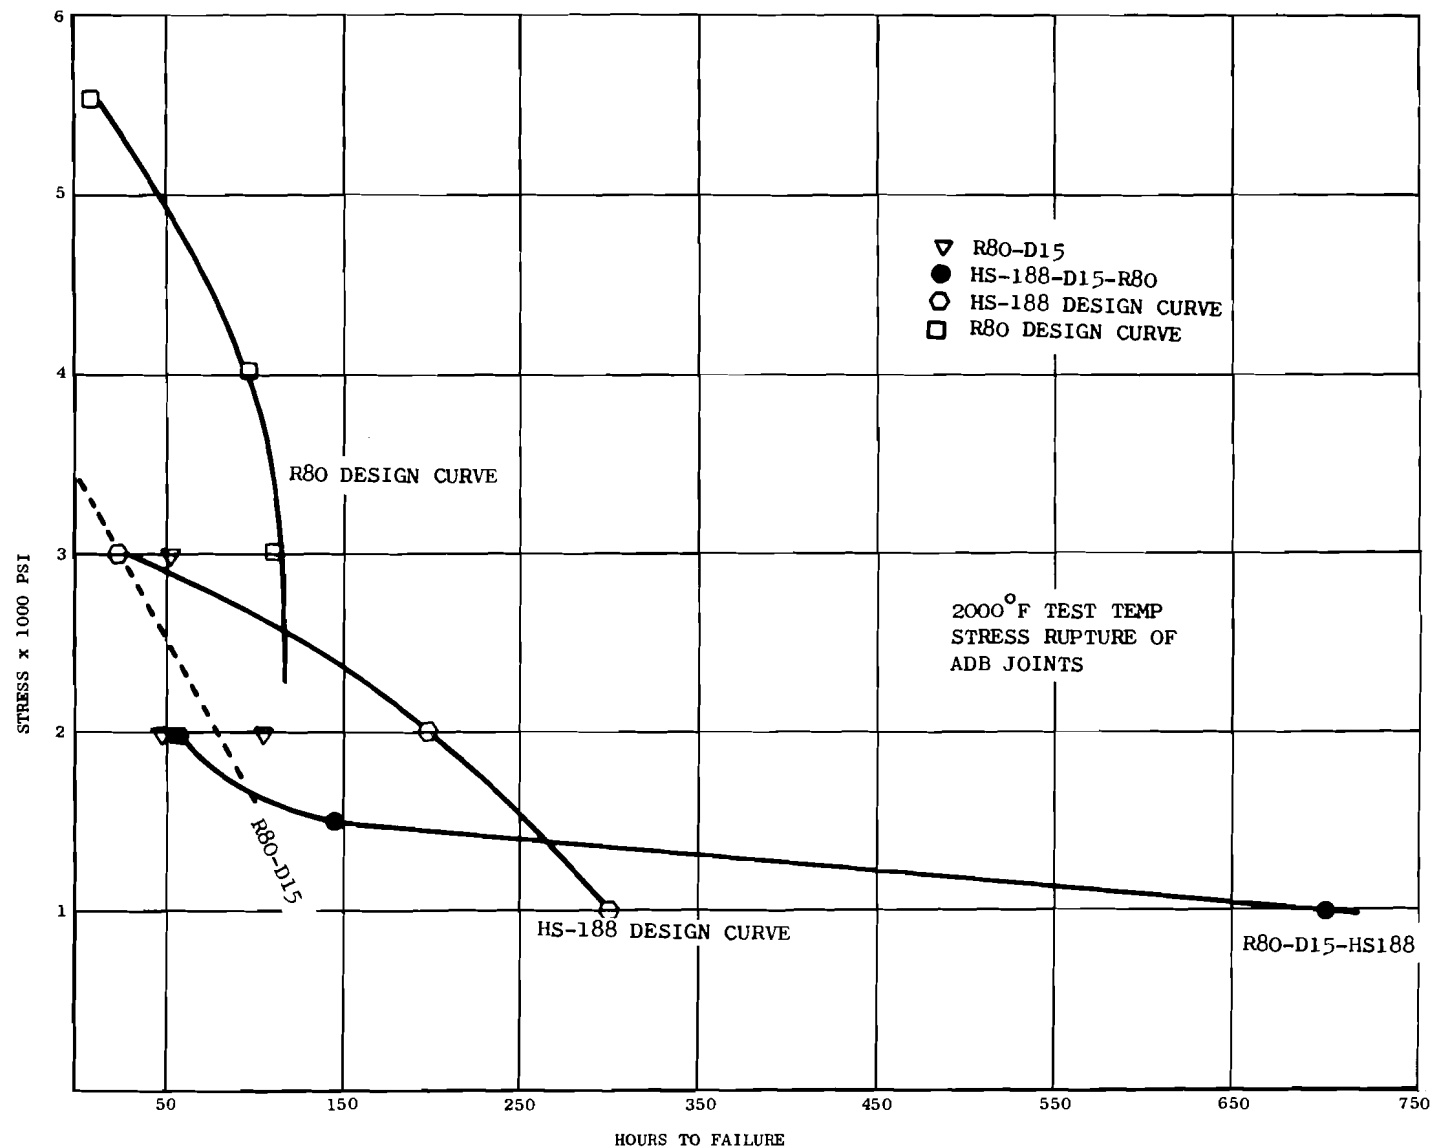
Stress rupture testing of minibonded joints at 2000°F, is shown in Figure 39 and indicates stress rupture values are comparable with the Rene' 80 and HS188 design curves. Although the actual values required for blades cannot be accurately predicted, these values coupled with prior CF6 engine testing of repaired vanes, provide sufficient preliminary data to proceed with TF39 engine testing.

Figure 39. Stress Rupture Test Results of Rene' 80 to Rene' 80 and Rene' 80 to HS-188 ADB Joints at 2000°F
